# **Limited Liability Company «Thermal Protection»**

## **CONCLUSION**

Based on the results of thermal conductivity properties tests of the multistore building No. 234, Block 3, at the Red Army prospectus in the town of Sergiyev Posad, Moscow district.

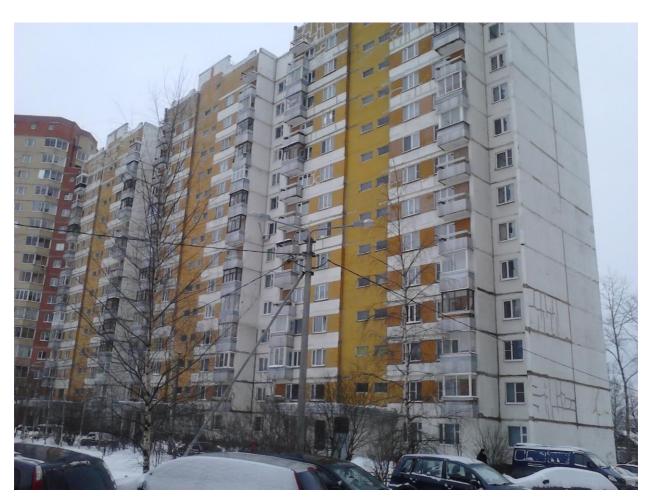
16 January 2013

The reason for this testing were numerous complaints and reports by the tenants about low air temperatures in the apartments and condensation of moisture on exterior walls in the apartments during the heating season.

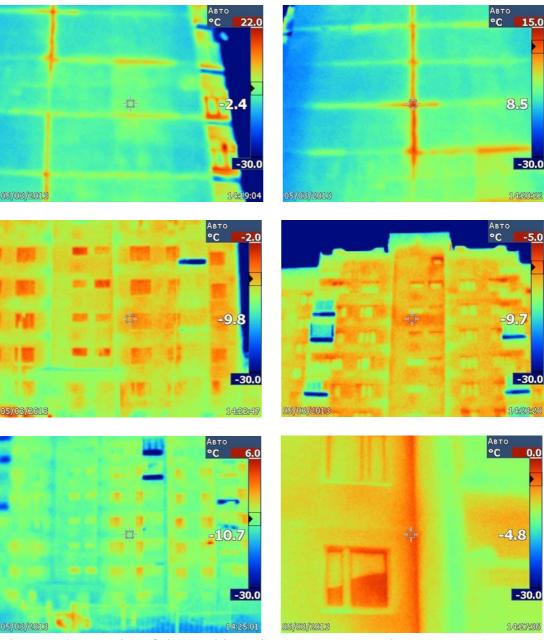
# Thermal imaging camera snapshot on $5^{th}$ of March, 2013. The outside temperature was -20°C.

Based upon the results of thermal imaging camera snapshot (Annex 1), calculations have been made, which determine the real thermal resistance of the building fence structure (envelope).

The calculation is based on the average outside wall surface temperature. The average outside wall surface temperature was -10,7°C.

The actual heat transfer thermal resistance of the outer fencing of the tested building is -maximum 0,90 m2°C / W.

The tested multistore building is not aligned to the sanitary standards. It is necessary to increase insulation of all outer fencings (envelopes) of the building.

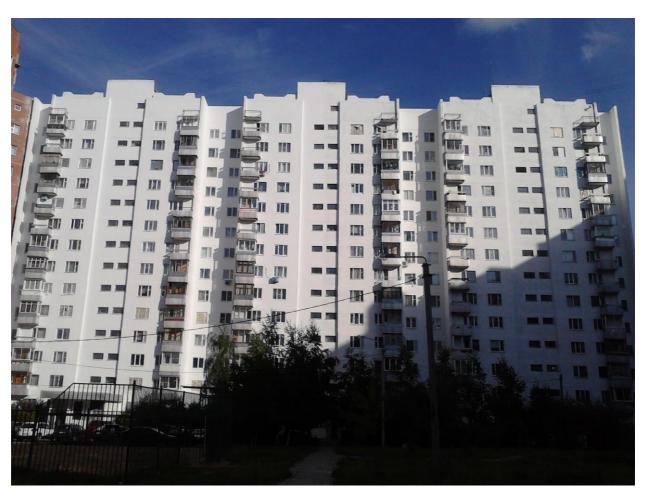
**7 October 2013**

4. Data of testing of insulation thermal conductivity characteristics after work execution.

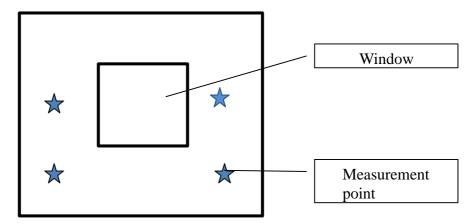
2. The temperature of the inner surface of the outer building fencing (envelope).

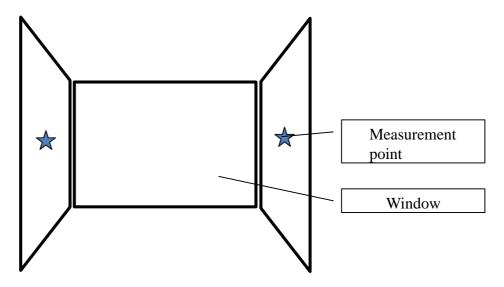
3. The temperature of the window slope inner surface.

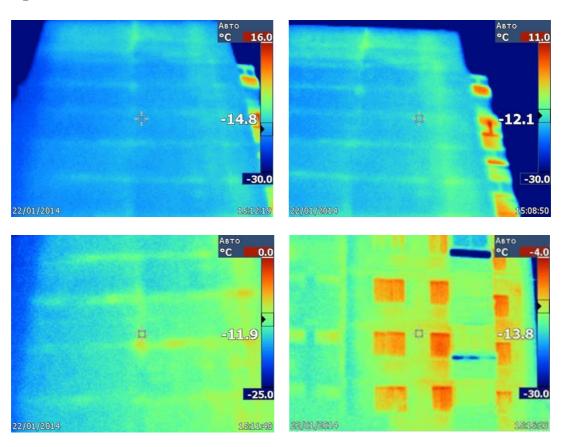
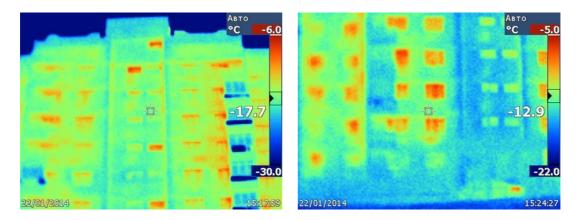
## Thermal imaging camera snapshot on 22th January 2014. The outside temperature was -20°C.

Based upon the results of thermal imaging camera snapshot (Annex 2), calculations were made, that determine the actual thermal resistance of the outer fencing of the building. The calculation is based on the average temperature of the outside wall surface.

The outside average surface temperature of the outer wall -17°C was accepted.

The actual heat transfer thermal resistance of the tested building outer fencing - over 2,51 m2°C / W.

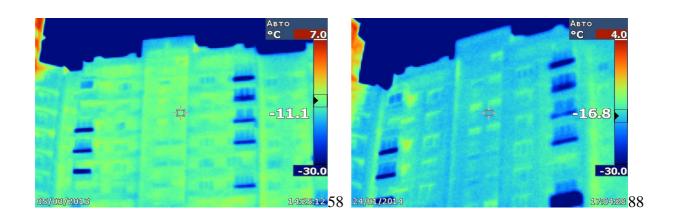
Before thermal insulation (5.03. 2013) Outside air temperature -20°C.

After thermal insulation (24.01.2014) Outside air temperature -20°C.

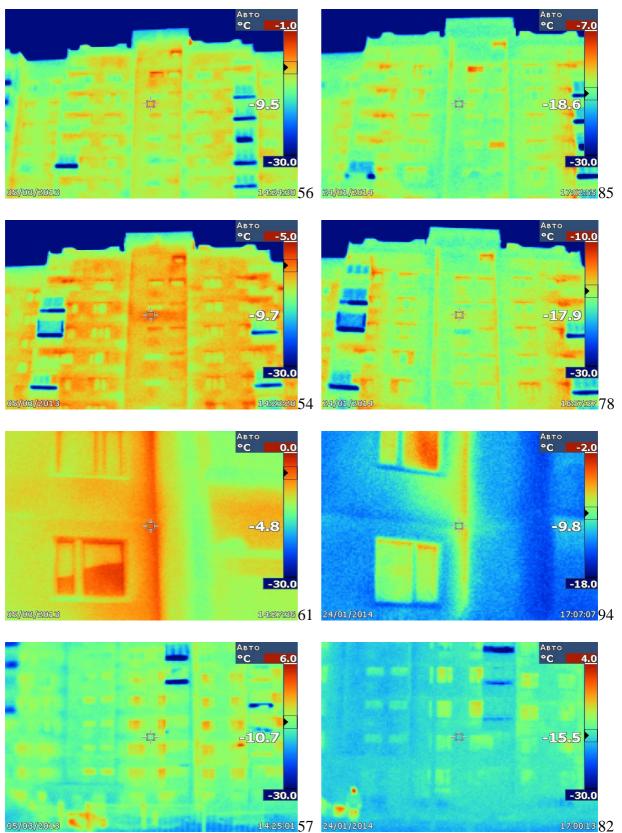
After thermal insulation(24 January 2014). Outside air temperature -20°C.

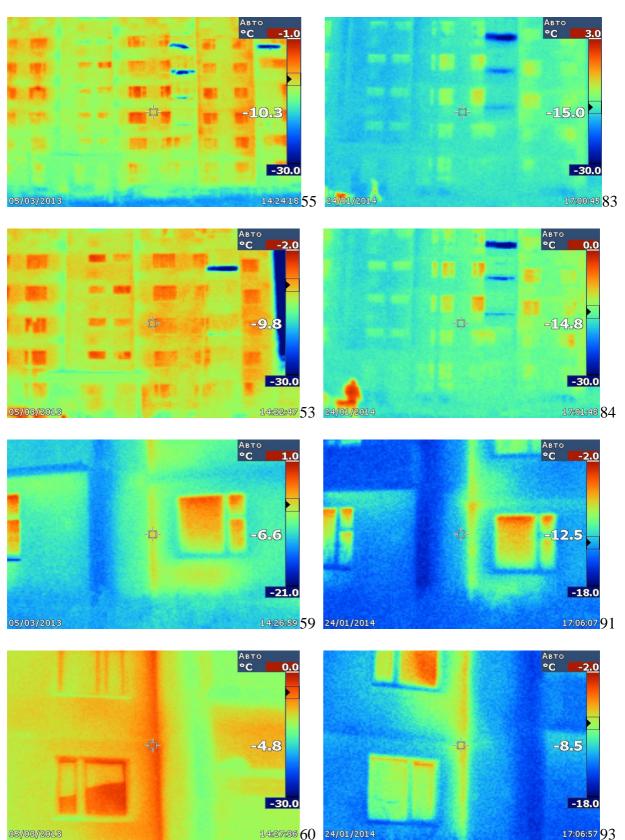
After thermal insulation (5 March 2013). Outside air temperature -20°C.

After thermal insulation (24 January 2014). Outside air temperature -20°C.

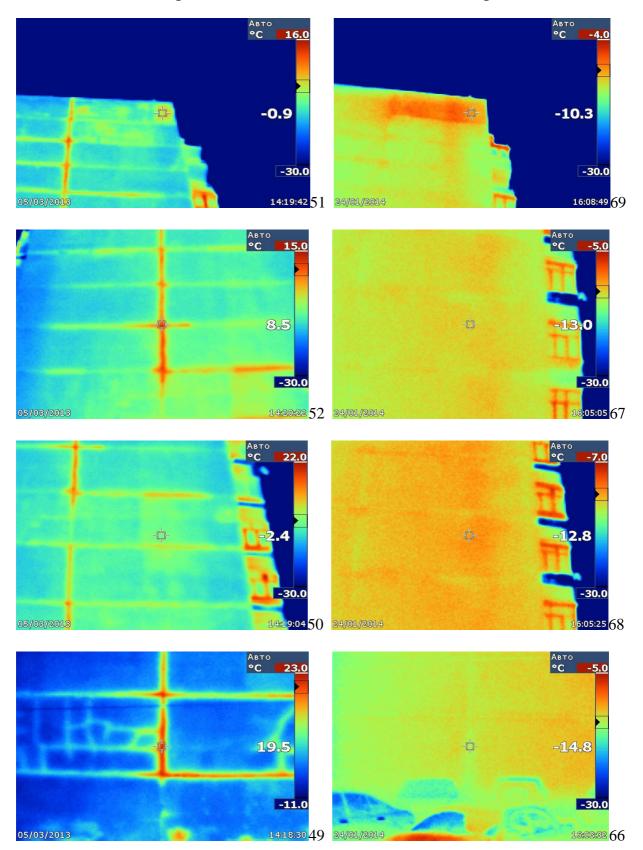
Before thermal insulation (5 March 2013). Outer air temperature -20°C

After thermal insulation (24 January 2014). Outer air temperature -20°C.

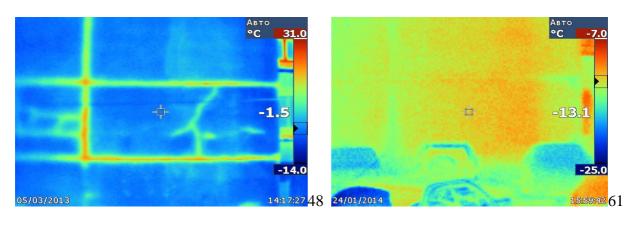
Before thermal insulation (5 March 2013). Outside air temperature -20°C

After thermal insulation (24 January 2014). Outside air temperature -20°C.

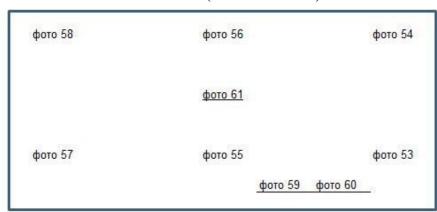
## Plan of thermal imaging camera snapshot

Before thermal insulation (5 March 2013)

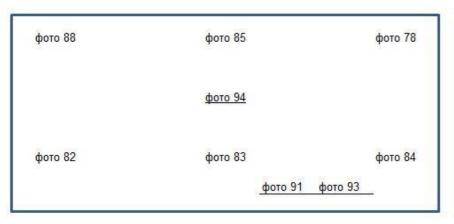
## After thermal insulation (24 January 2014)
